Hawk-Eye Home Inspections

Summary Report

Sample Report

| Date of Inspection 05/31/2007 | Arrival Time 09:00 AM | Departure Time 10:30 AM |

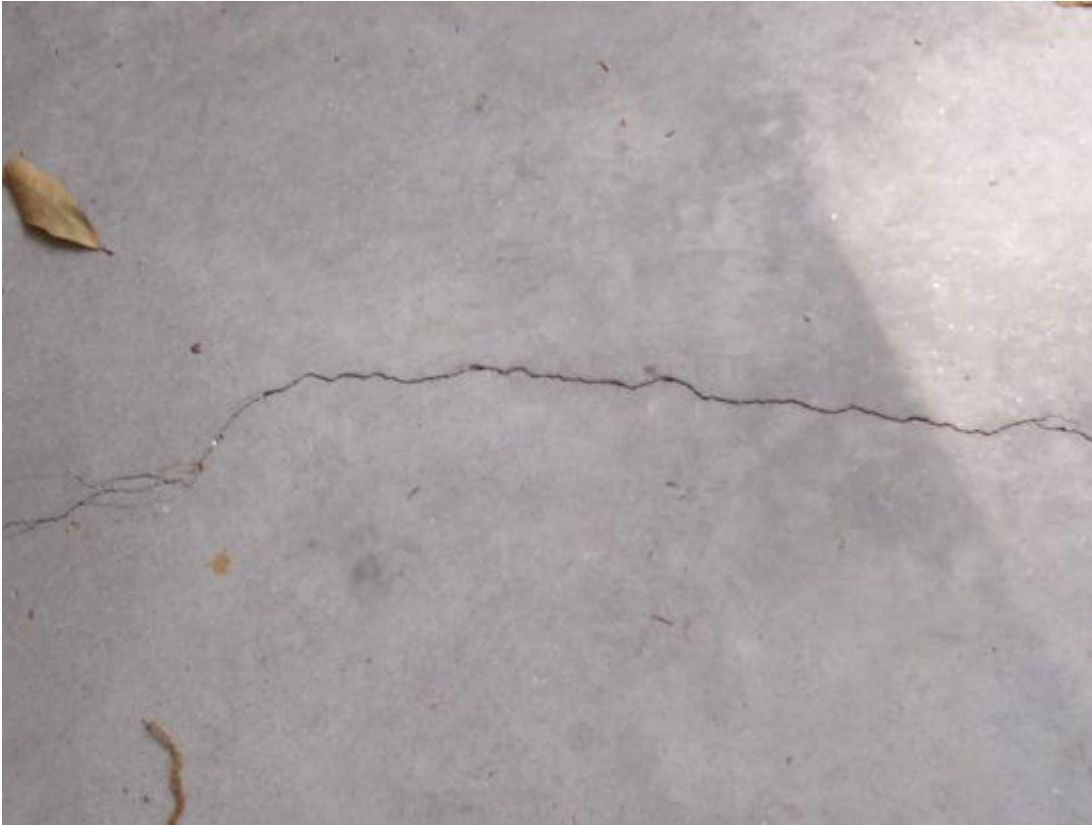
Concrete driveway has Hair line cracks through it. Most of these cracks appear cosmetic at this time. Cracks that become separated or un-even more than an inch should be repaired.

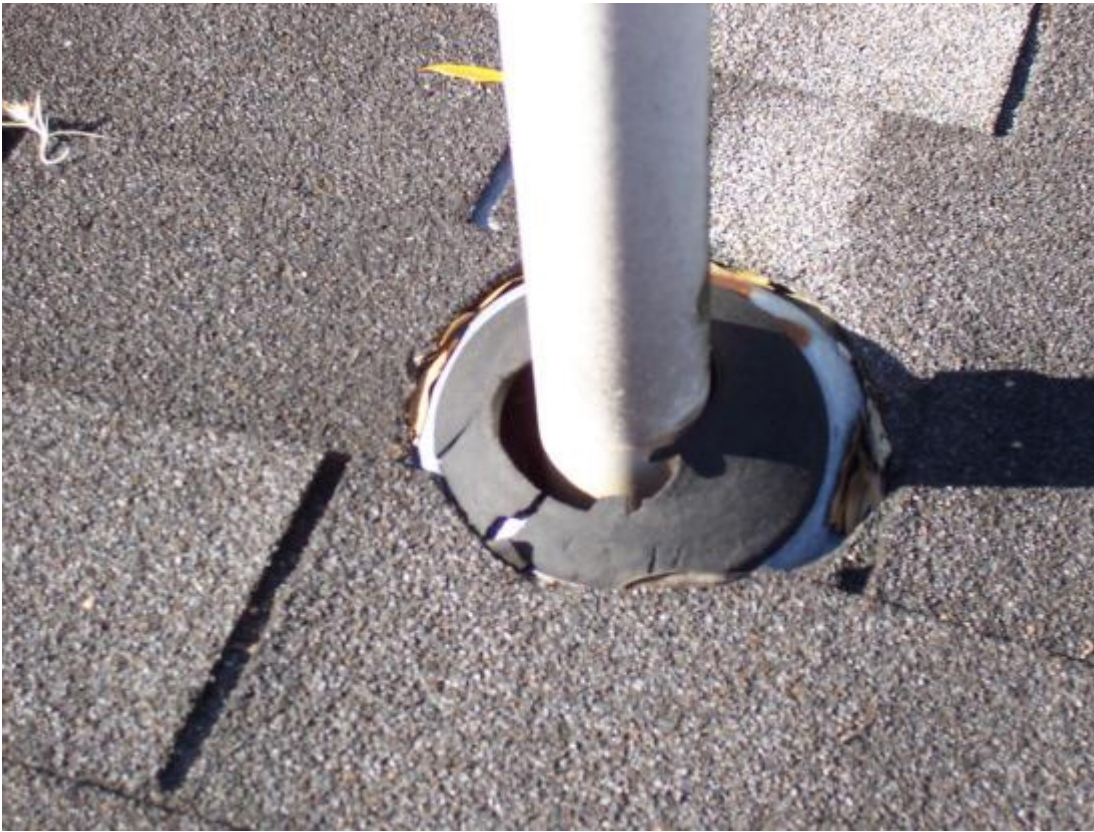
Boot vent shows deterioration of rubber seal around the plumbing pipe. This could allow water to penetrate into the attic area. See attic section for water penetration.

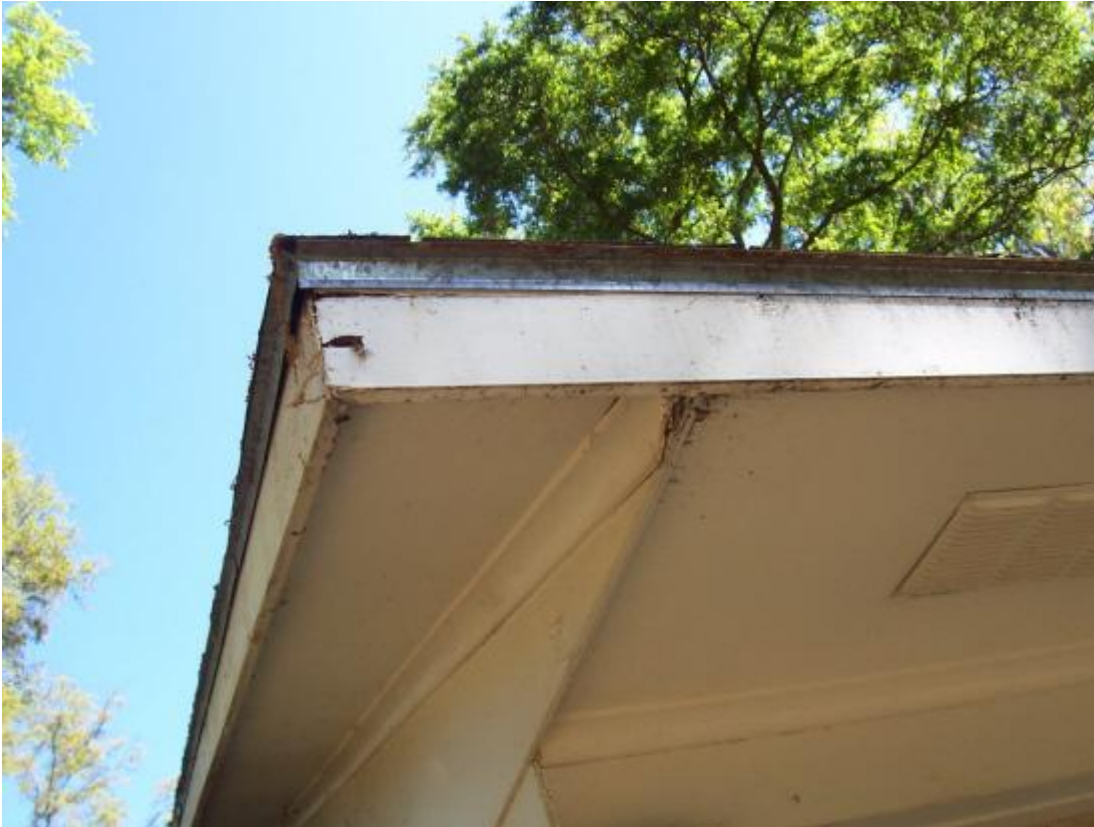
Dry rot found on the fascia board located on the following section(s): back right corner of the home.

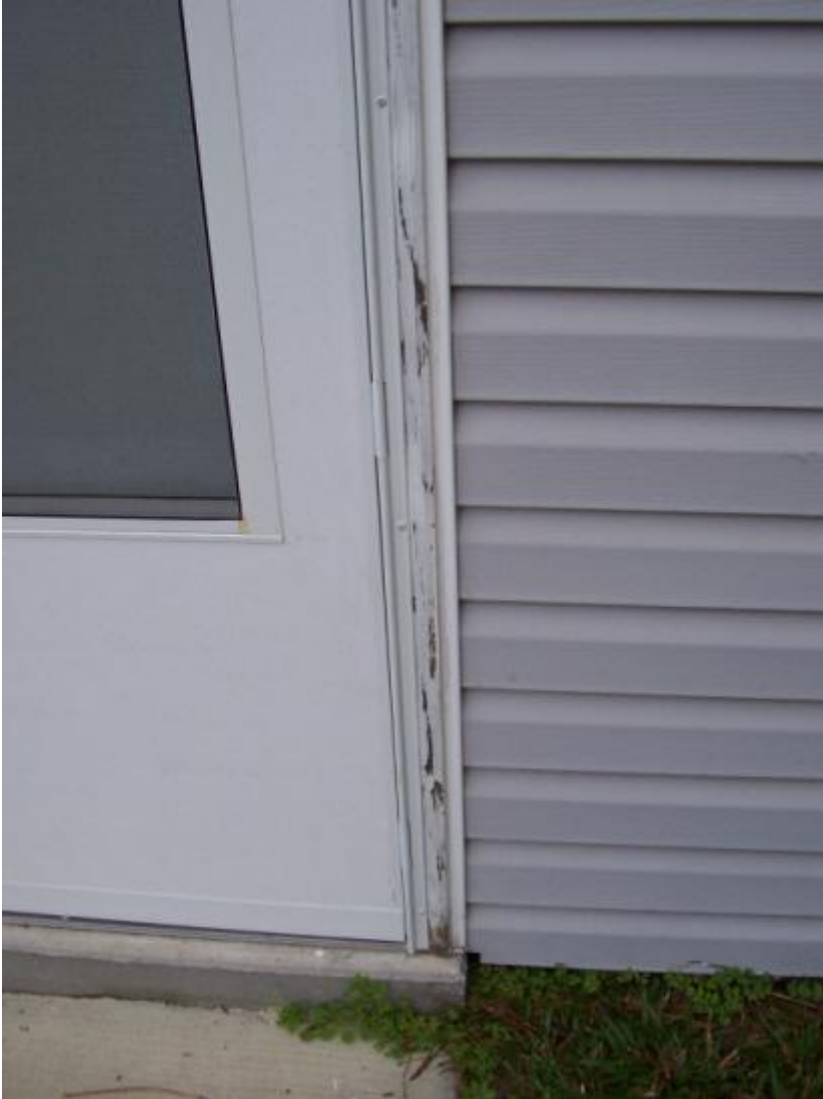
Paint peeling on the exterior wood surfaces that will require chipping, sanding, priming and painting.

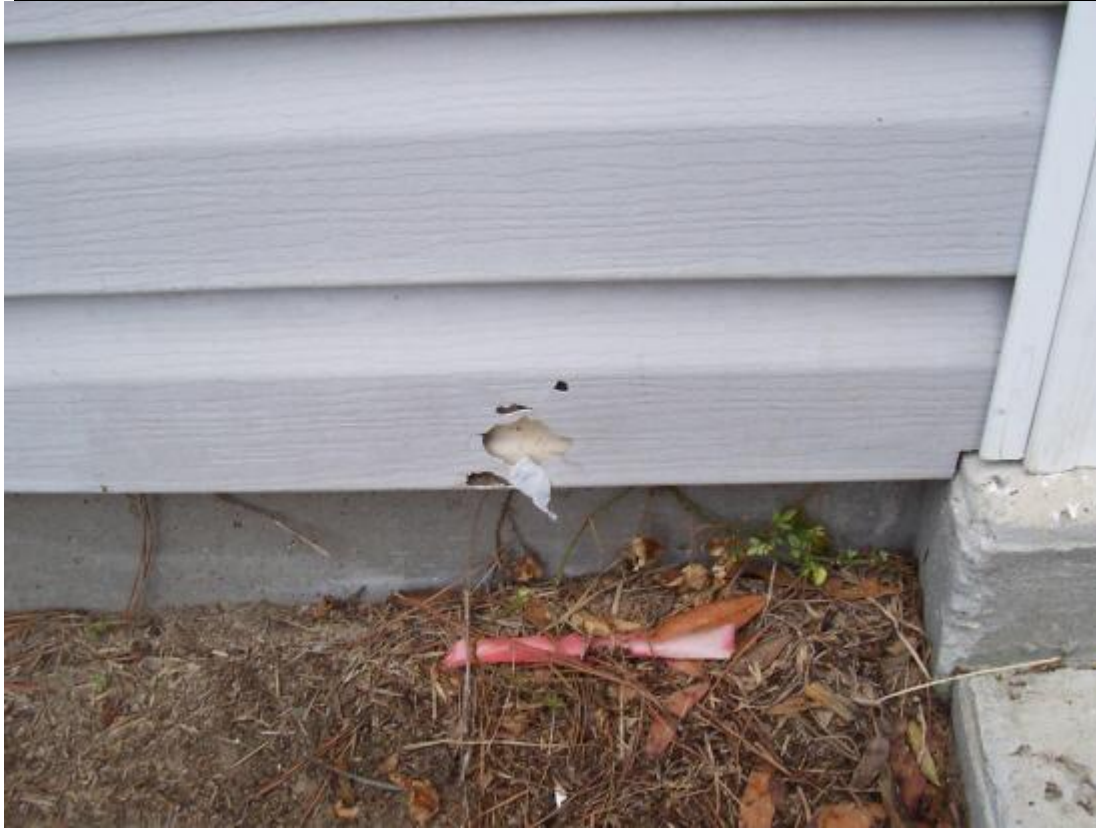
Vinyl siding had holes found on the following section(s): bottom section along the back of the home.

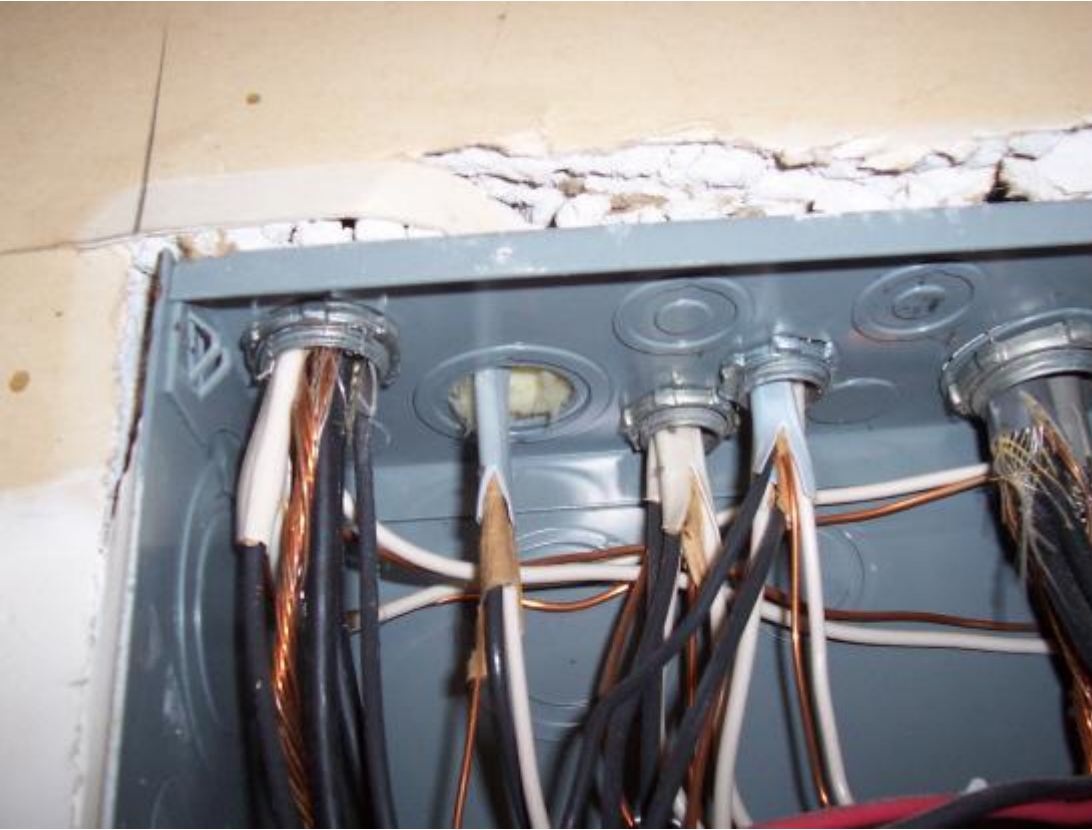
Outgoing wires in the breaker box do not have wire fastener's installed. Wire fastener's prevent wires from fraying and possibly shorting.

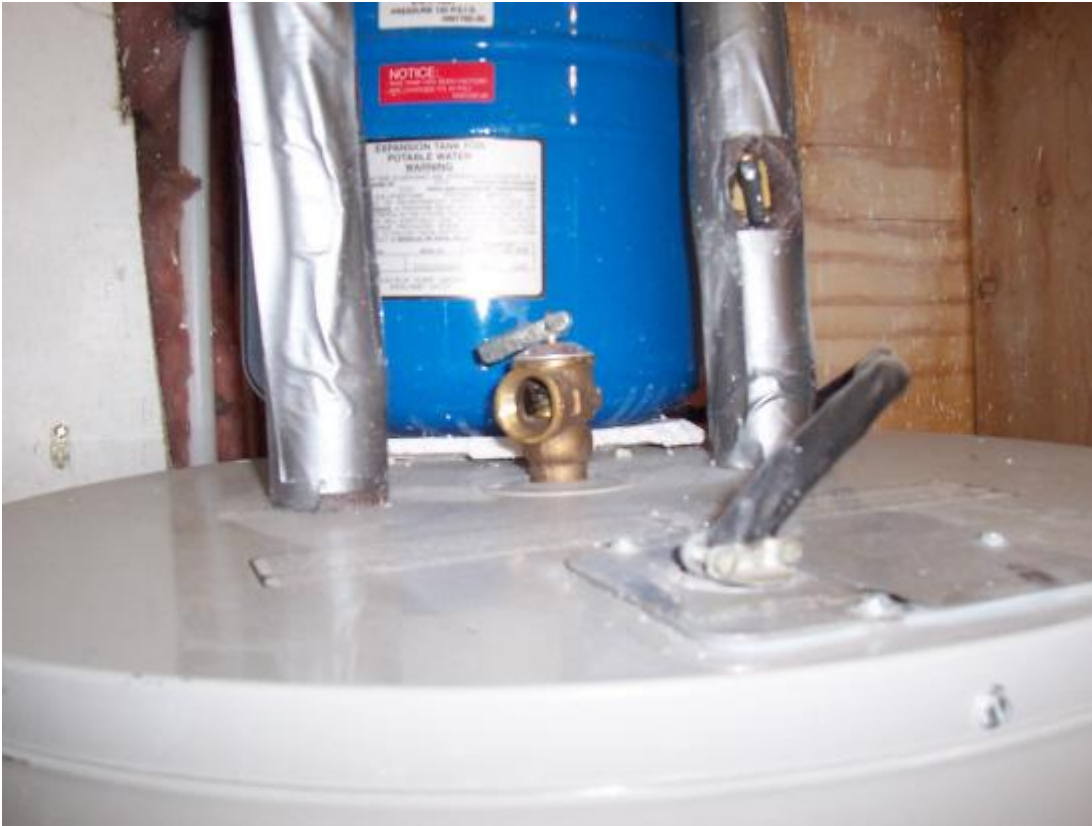
Pressure Relief valve for the water heater was not duct to the exterior wall or in a safe manner off of unit.

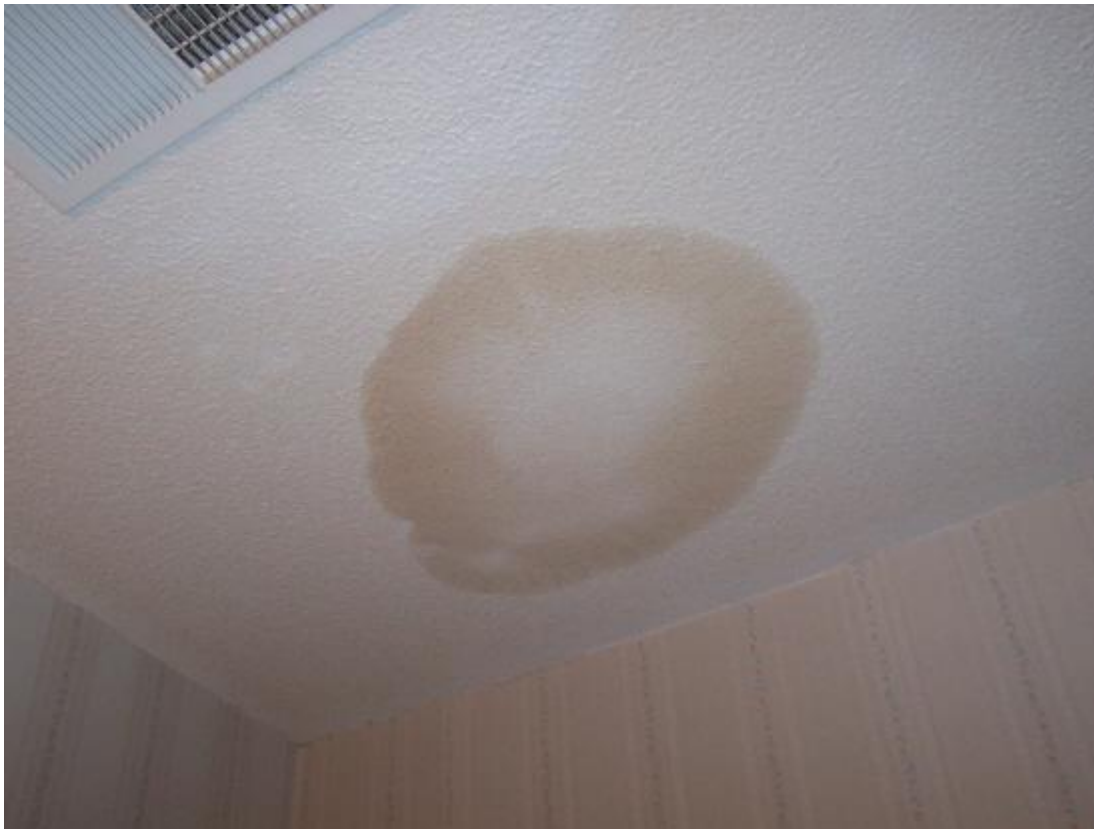
Water stains found in the ceiling area of the living room. Moisture readings show leak to be an inactive leak (no moisture) at the time of inspection.
